**South Shore Vocational Technical School
District Facilities Master Plan**

Drummey Rosane Anderson Inc.

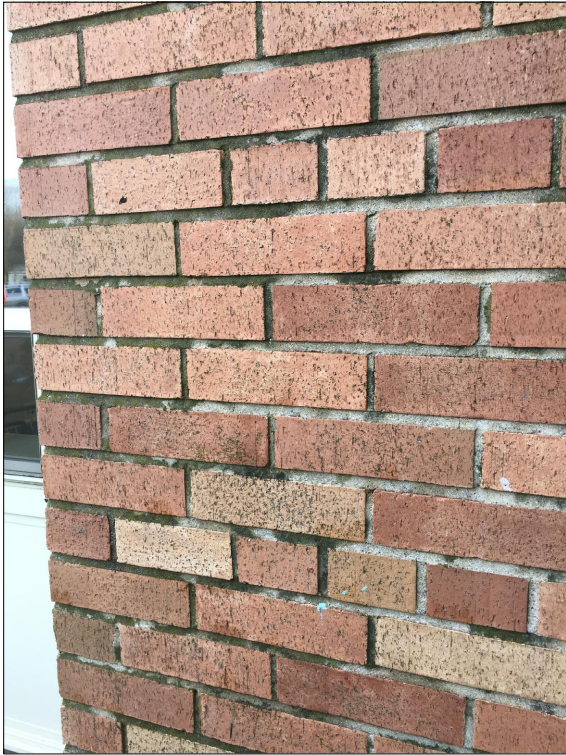
Evidence of moss growth on brick pier near main entrance
- water runoff from canopy above

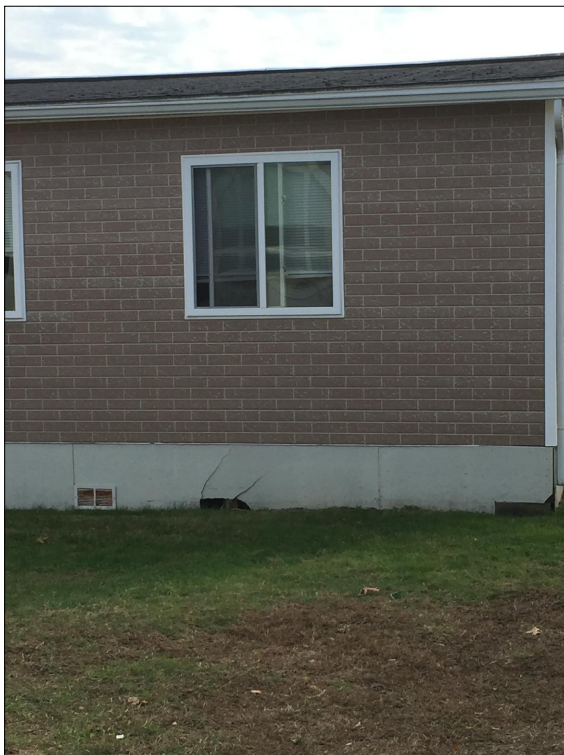
Damage to lower wall sheathing at the modular classroom expansion.

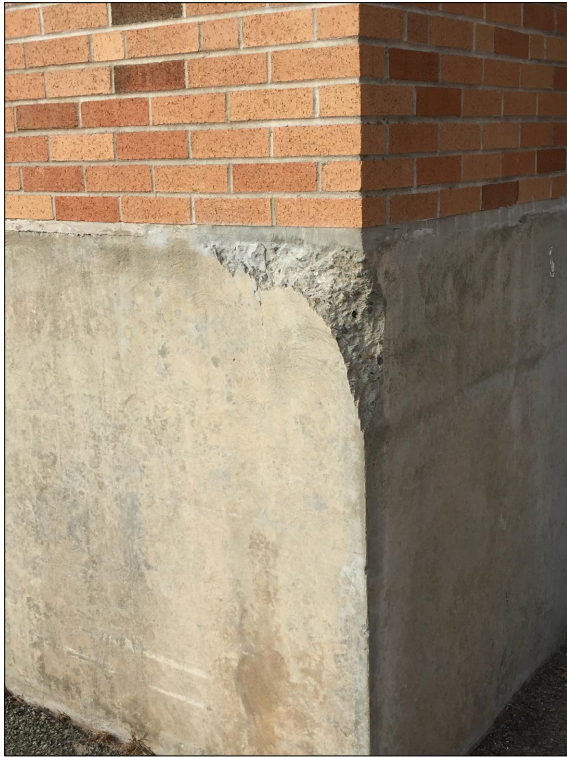
There are some minor sections where concrete base wall has some damage. These sections should be patched as part of a larger renovation project.

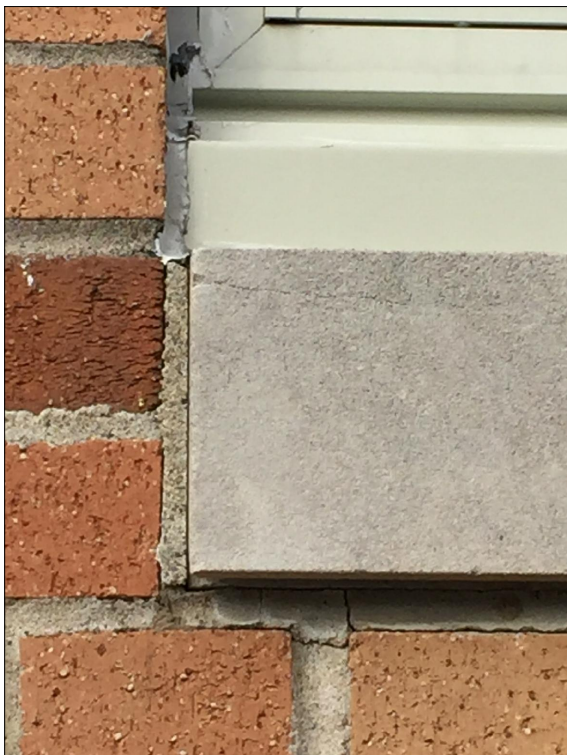
There were some areas, particularly under windows, where some masonry re-pointing would be suggested.

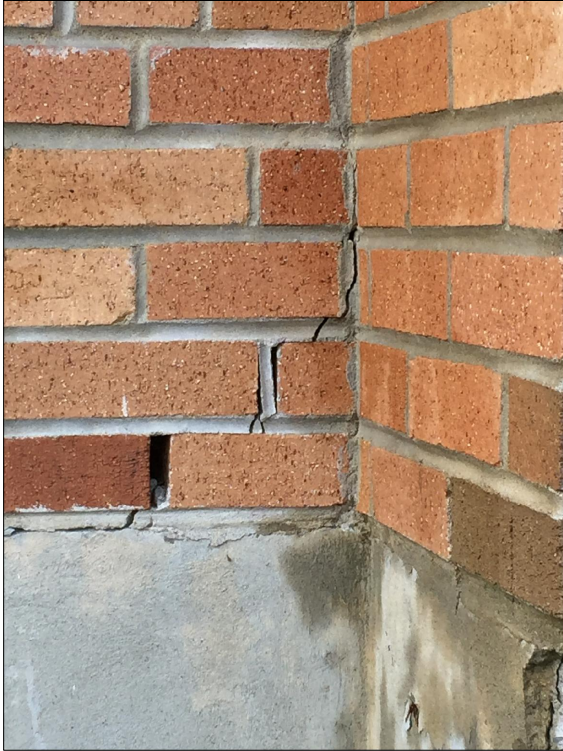
These appear to be some settlement cracks which should get patched.

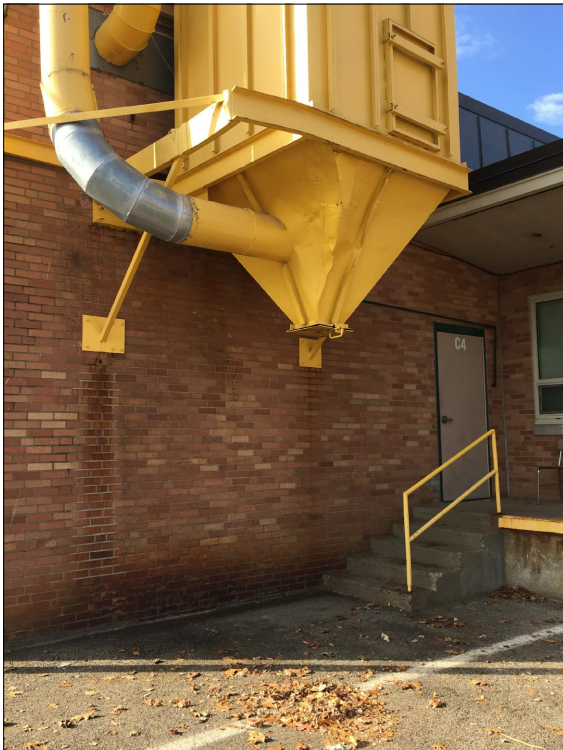
Damage to section of dust collector - hit by trucks in the loading dock area.

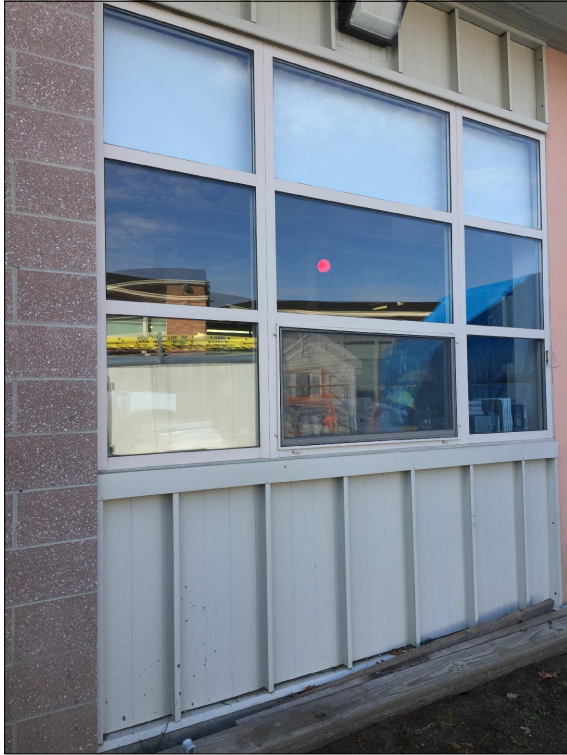
Typical window assembly at the 1992 addition - windows above with operable sections and metal wall panels below.

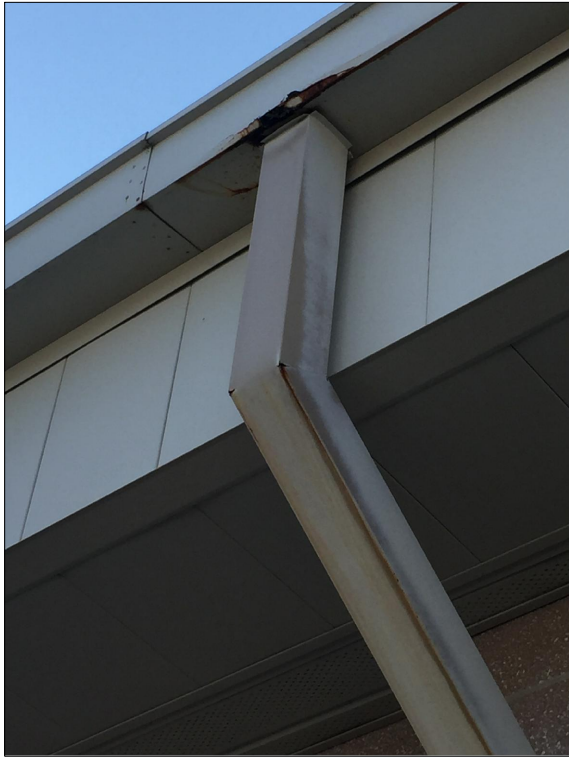
Gutter and downspout at 1992 addition - need to repair damaged fascia. Gutters and downspouts are starting to rust out.

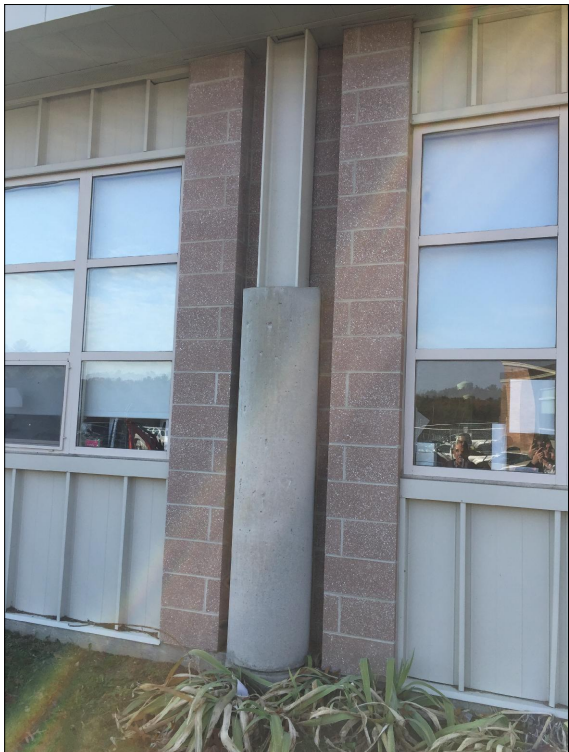
Typical exterior column detail at the 1992 addition.

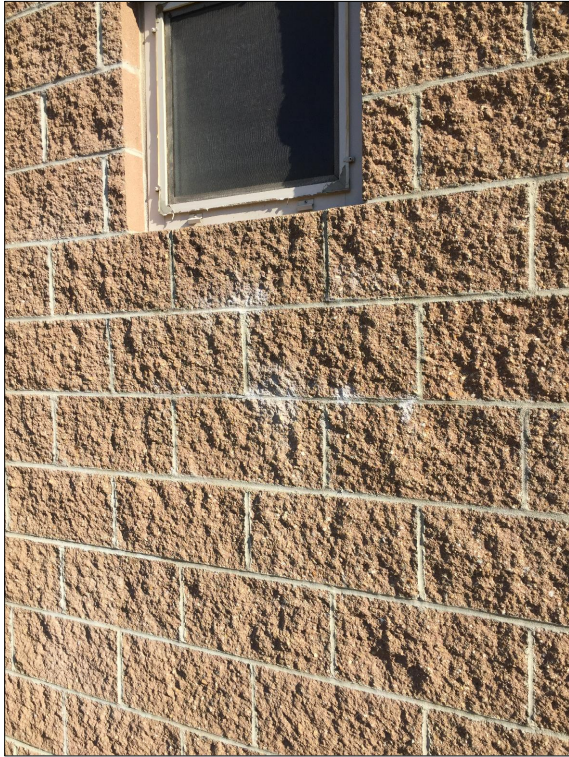
There were some minor spots of efflorescence noted in the 1992 addition.

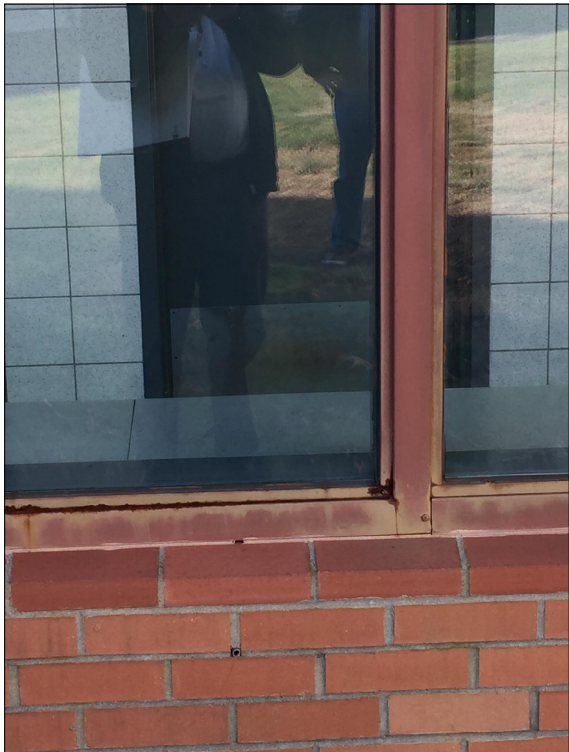
Evidence of rusting at the windows frame in the 1992 addition.

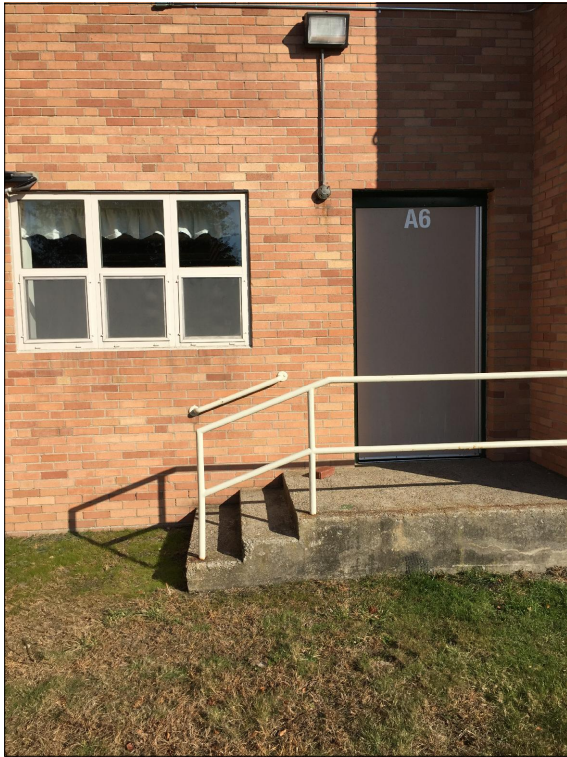
Secondary means of egress from the cafeteria is not considered accessible.

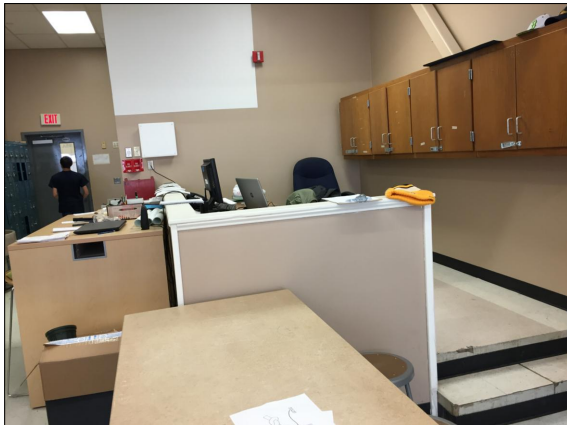
Elevated teachers areas, located in several shop areas (such as automotive and electrical shops), are not considered accessible and should be replaced.

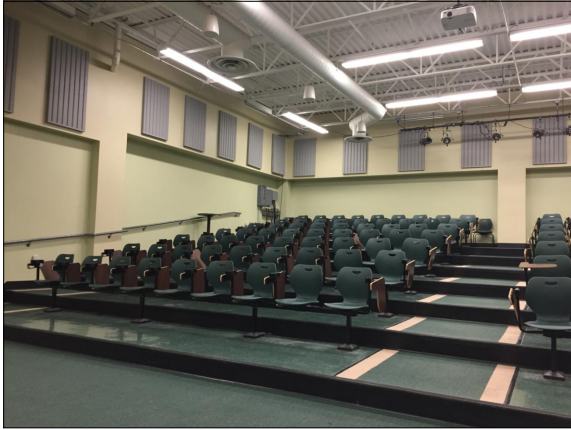
Interior photograph of the seating at the lecture hall. Will need to provide handicap accessible spaces at both the upper and lower level seating areas.

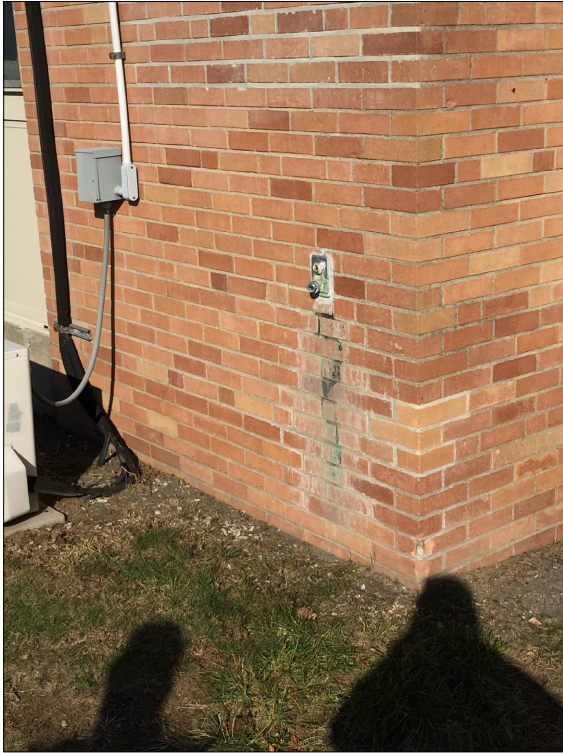
Typical exterior hose bib connection - masonry to repaired / patched.

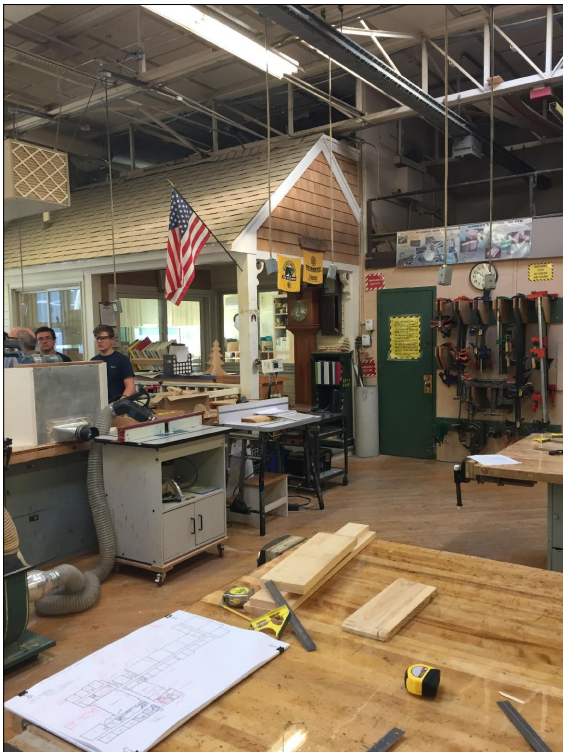
Interior of the carpentry shop. The shed structure is the office area and is not accessible.

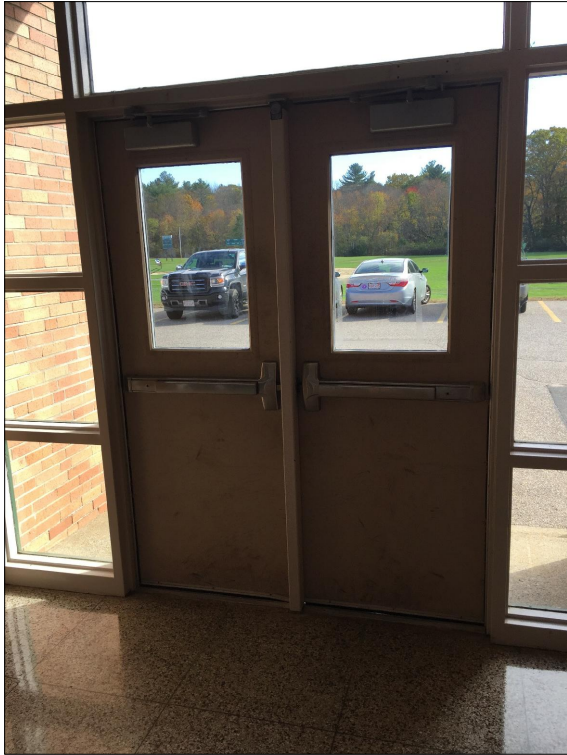
Pair of doors at egress at a pair of 2'-8" doors which are not considered accessible. Doors should be replaced with one leaf at least 3'-0" wide.

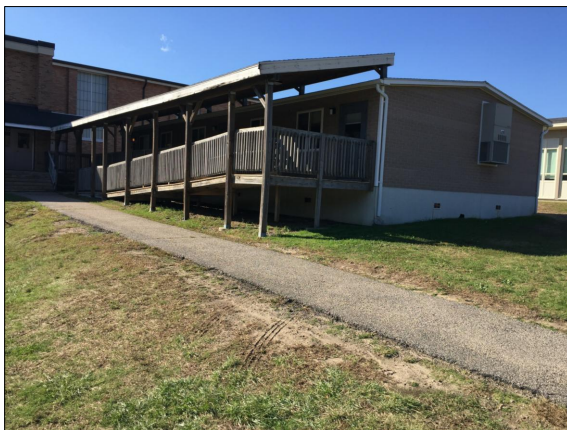
Modular classroom expansion with wood frame entrance stairs and ramp.

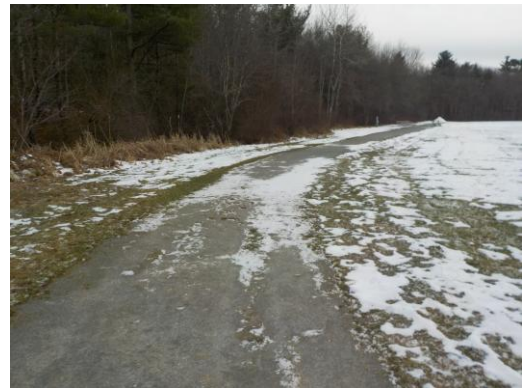
Figure 3 – Existing Stone Dust Track

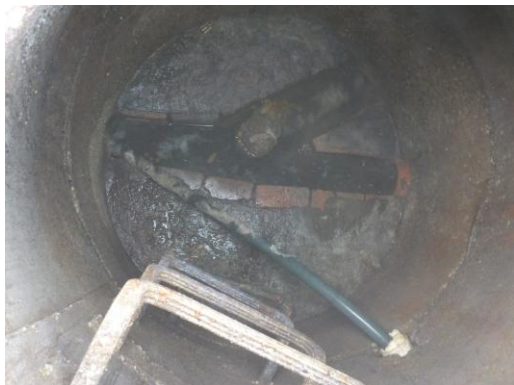
Figure 5 – Sewer Manhole with what is Believed to be the Force Main from the Concession Stand

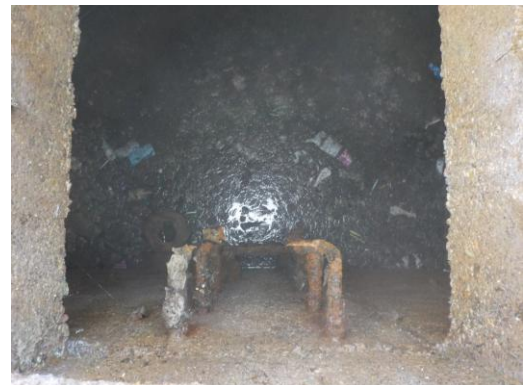
Figure 6 – View of Septic Tank Manway with Corroded Steps

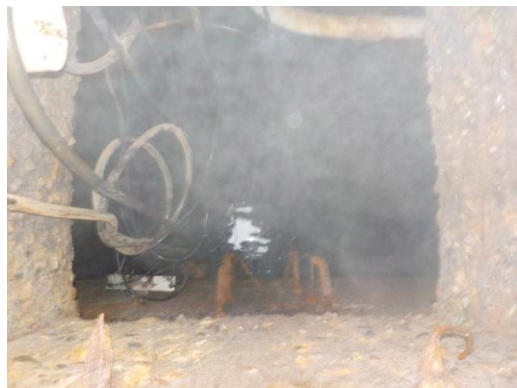
Figure 7 – View of Pump Chamber Manway with Power & Control Wiring

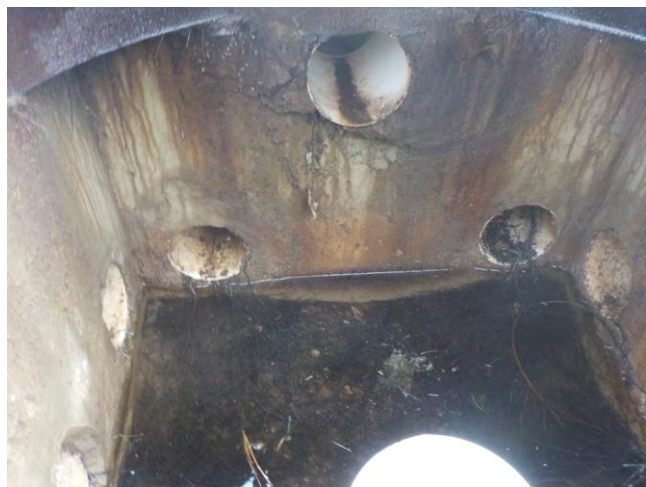
Figure 8 – View of D-box Serving the West Side Soil Absorption System

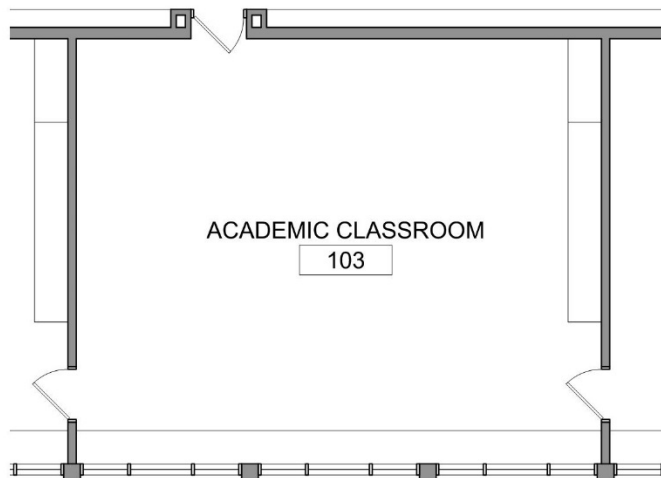
Rooms were recently renovated - classroom entrance not accessible

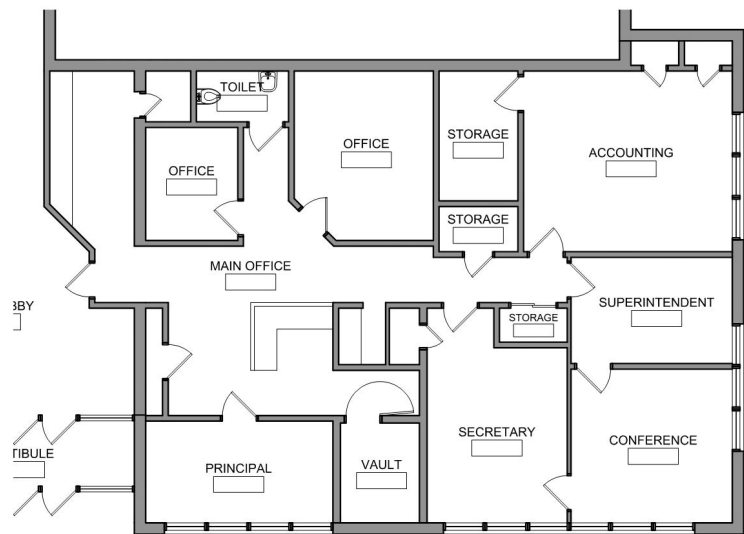
Recommendations	Would prefer to be more centrally located
	Install new fire protection system
	Replace existing ceiling with new high NRC 2x2 ACT ceiling
	Install new LED lighting with new lighting controls
	Replace existing carpeting

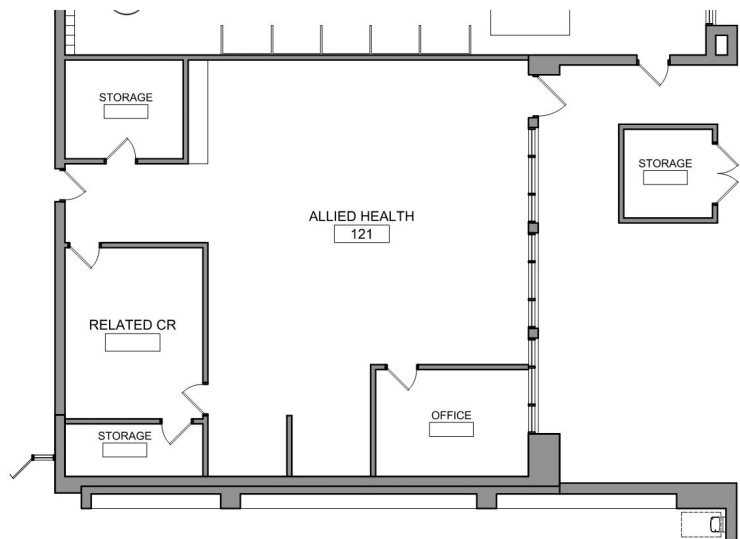
Contains office, storage and small related classroom

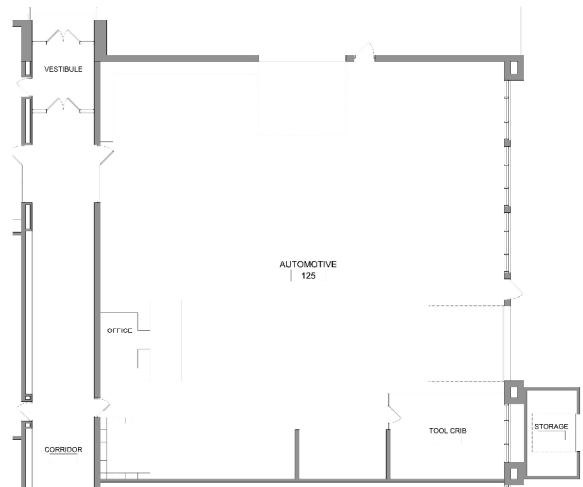
Tool crib, locker area with sink

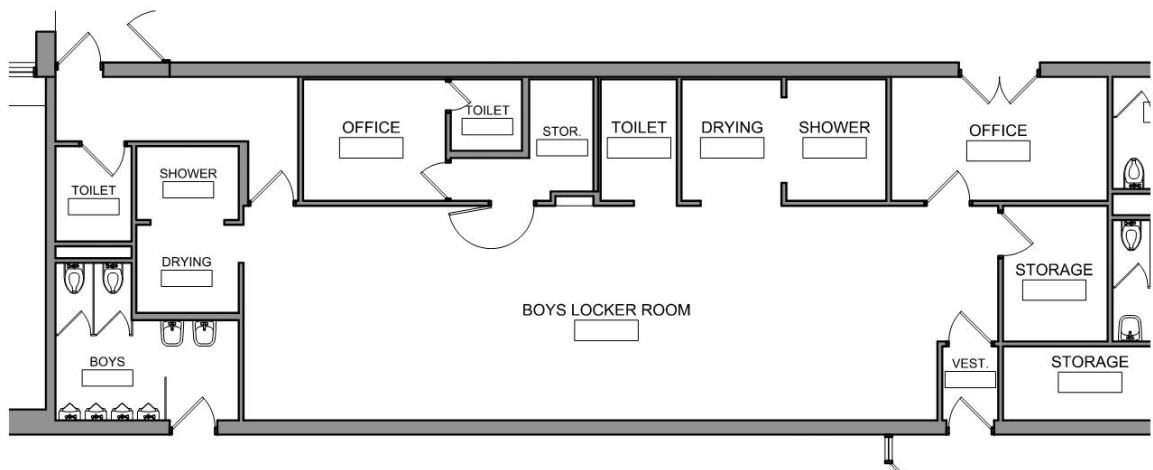
Room is somewhat cramped

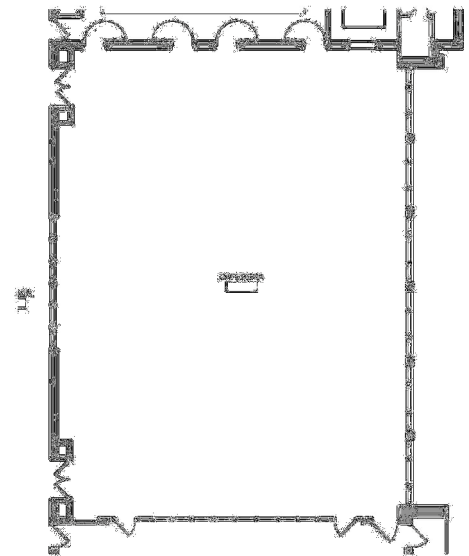
Recommendations	Replace existing plaster ceiling with new high NRC 2x2 ACT ceiling
	Replace entrance doors with a doors at least 3'-0" wide
	Install fire protection system
	Install new LED lighting and new lighting controls

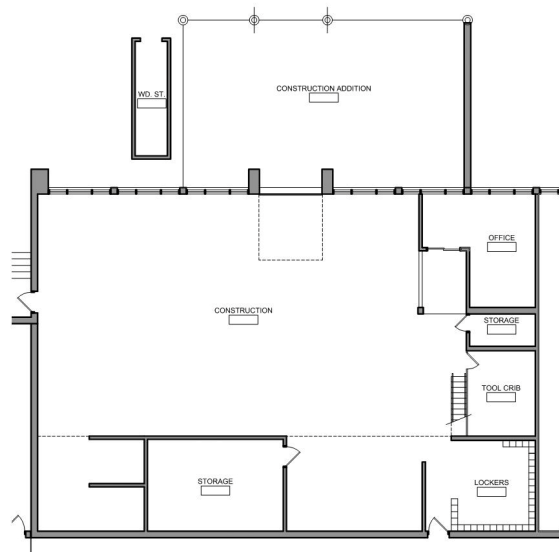
Contains office, tool crib and storage room

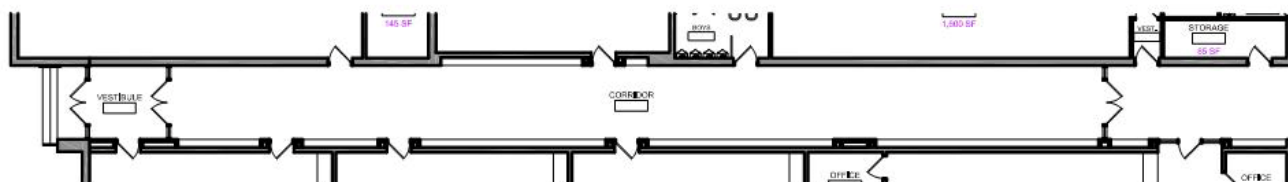
Some of the corridors have received new LED lights this year

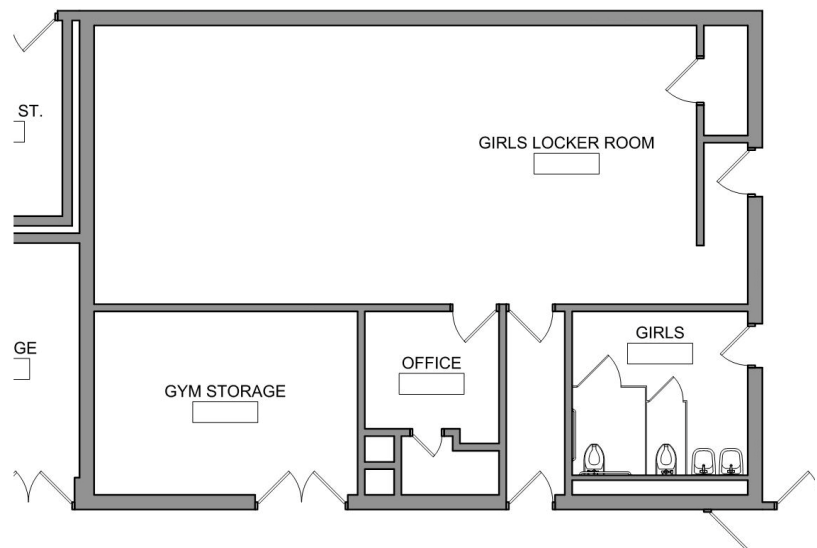
Some rubber mats on the floor

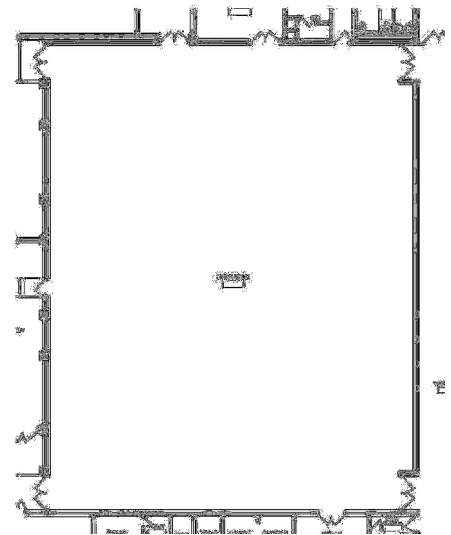
Side folding curtain

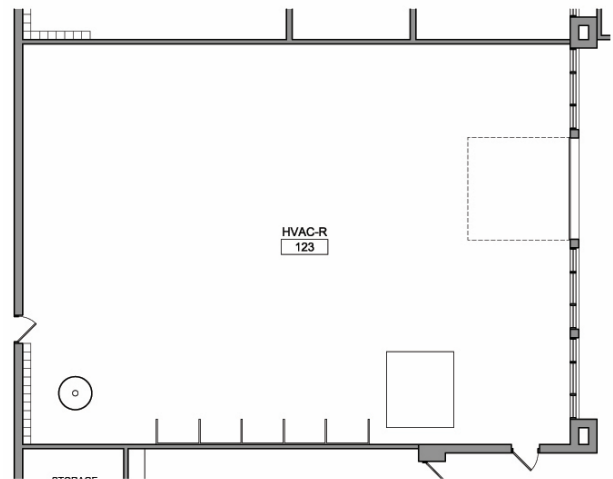
Teacher area within shop - no related classroom

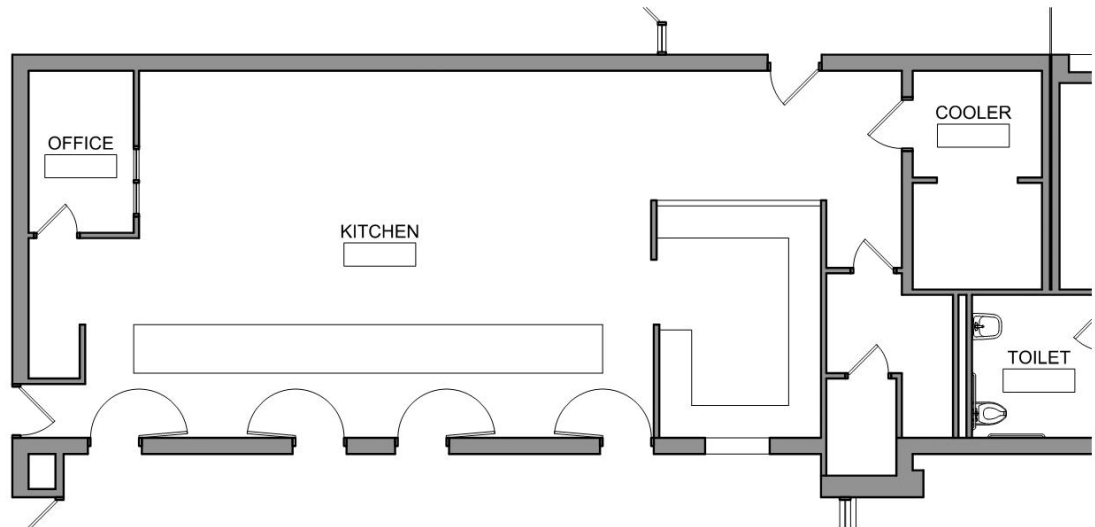
The freezer is located across the hall in the loading area

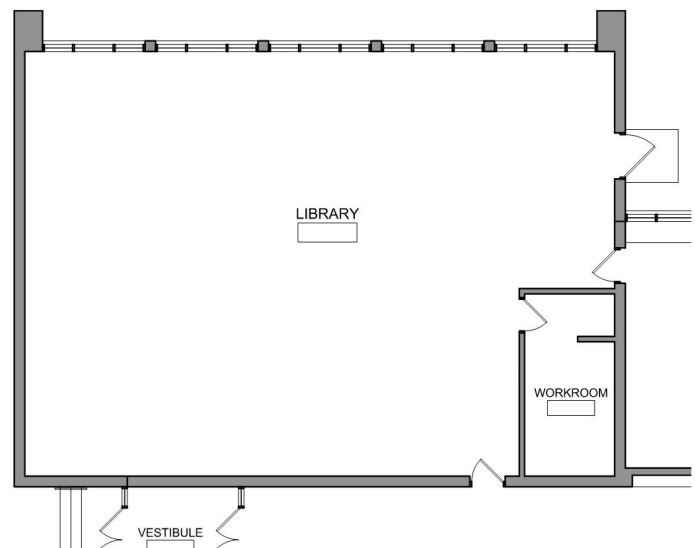
There is a work room off the library

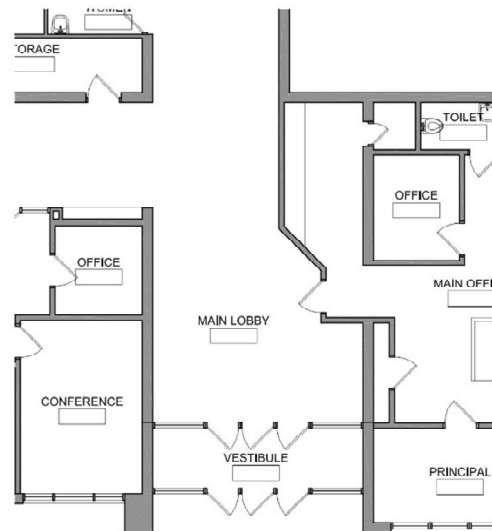
Some throw down rugs

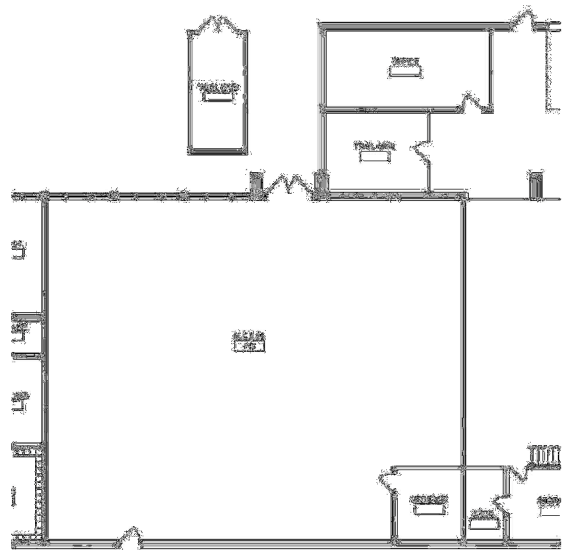
Has a smartboard / overhead bus duct

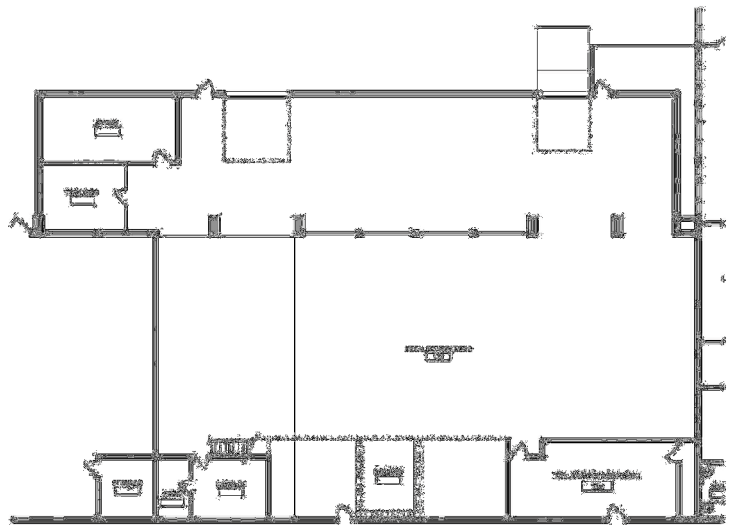
Upper storage area, small related classroom, storage area

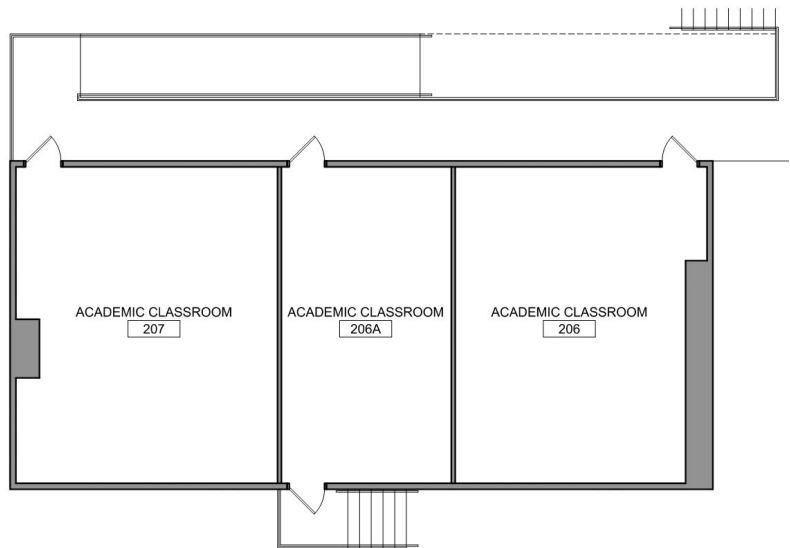
All classrooms are significantly undersized

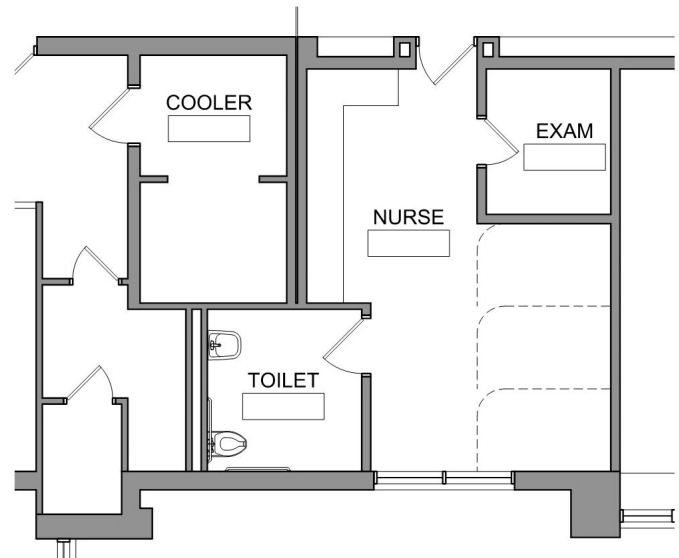
There is a toilet room with ceramic tile floor and wall wainscot - GWB above

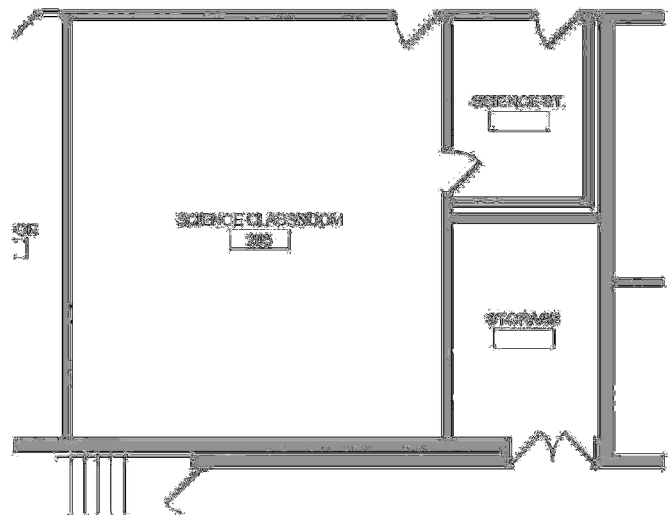
There is gas in two of the labs (room 201 & 205)

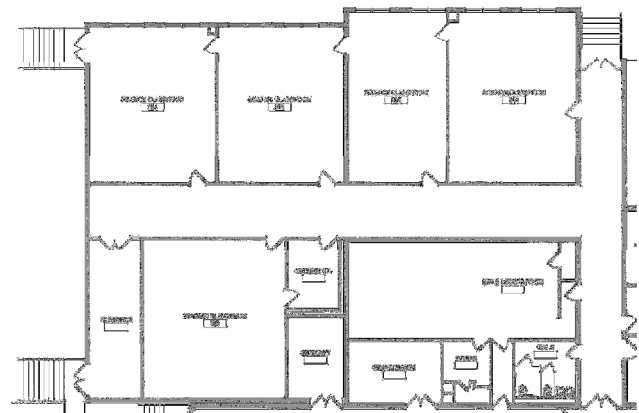
Some tack boards along corridor walls

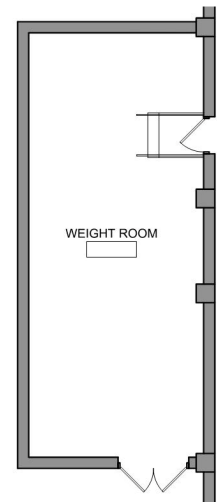
Recommendations	Recommend replacement as part of larger renovation project
	Make exterior step outside accessible

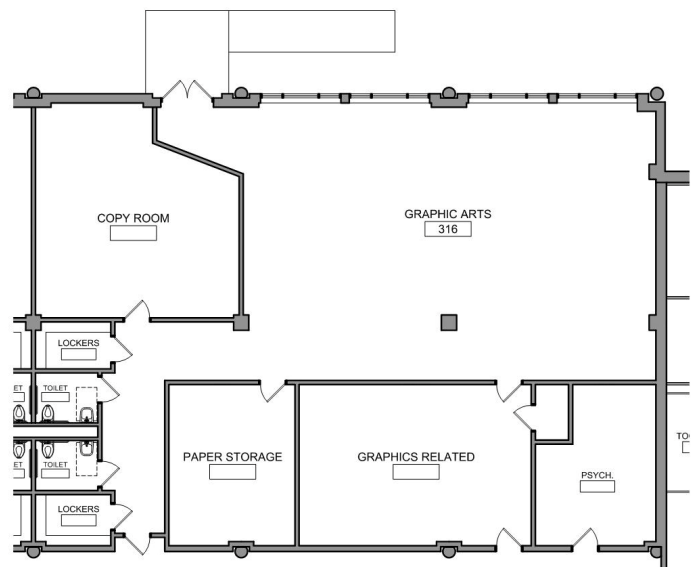
Copy room, related CR, paper room, separate toilets, flammable st.

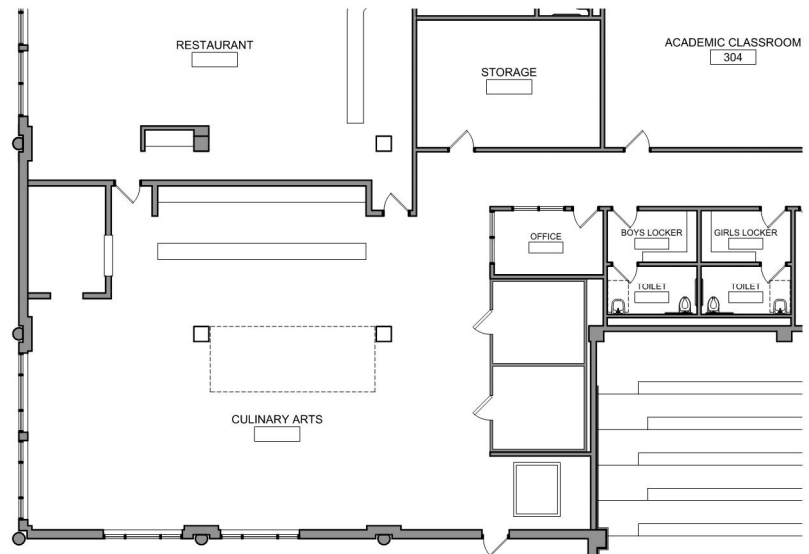
Wood paneling vs. ceramic tile for walls at restaurant

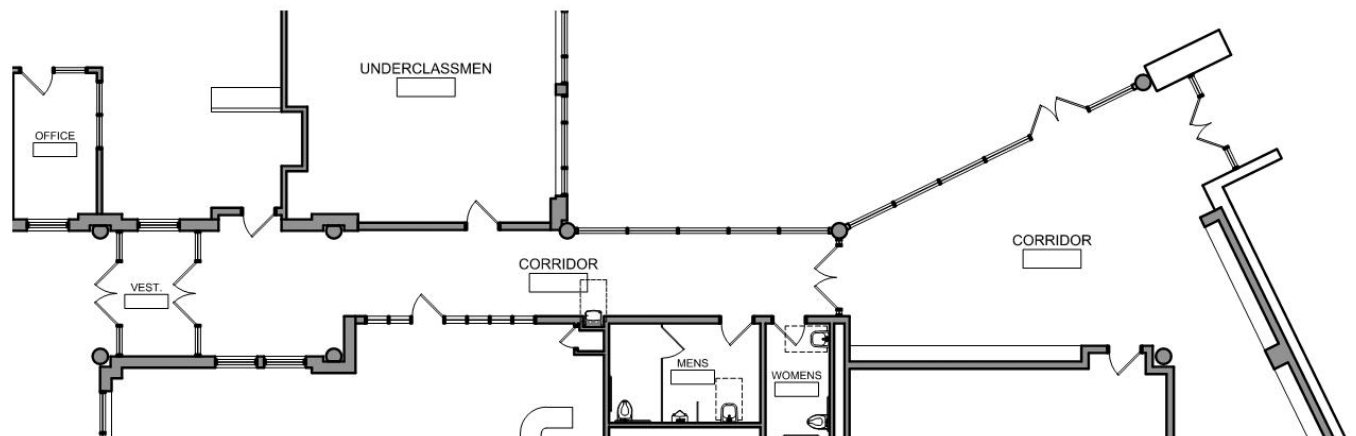
No terrazzo, wood slat ceiling outside lecture hall

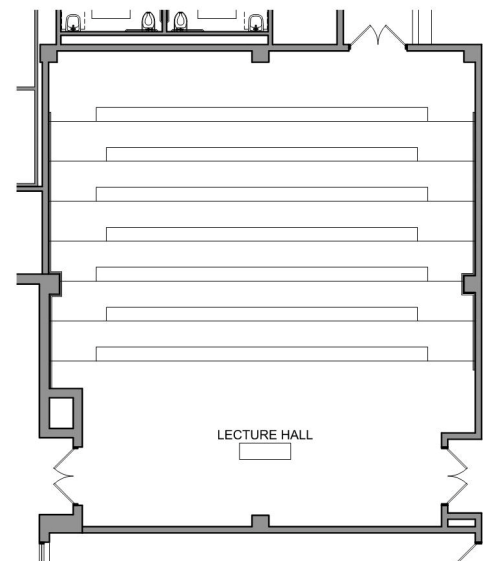
No access to back of lecture hall (carpet, VCT and seats replace 5 yrs ago)

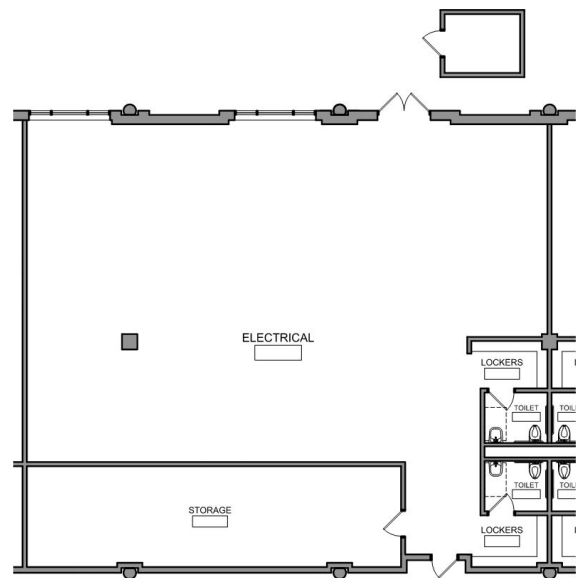
Raised teachers station, upper student carrels, lockers and toilets

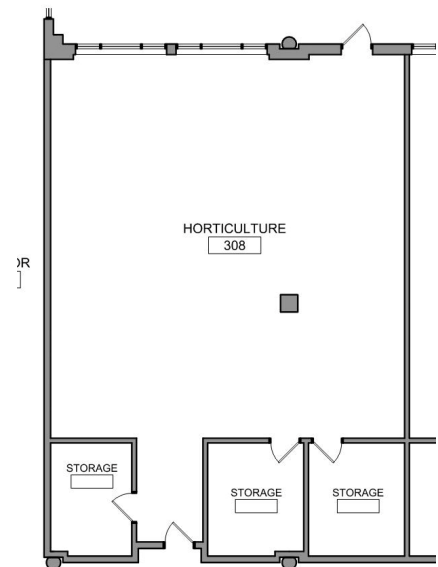
Raised teachers station (not accessible)

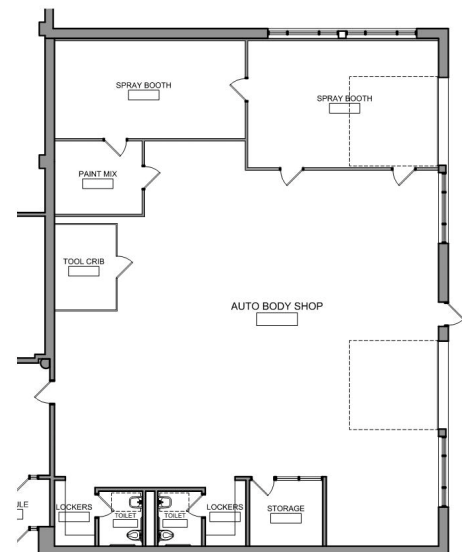
Contains office, tool crib, locker areas, and two toilet rooms

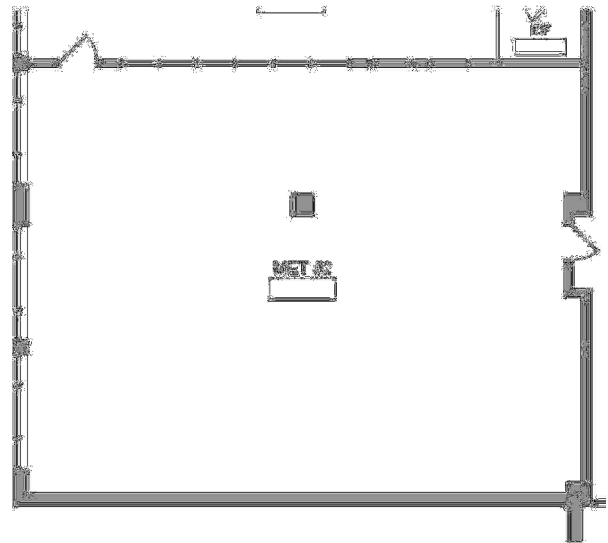
Laid out as a computer lab (engineering)

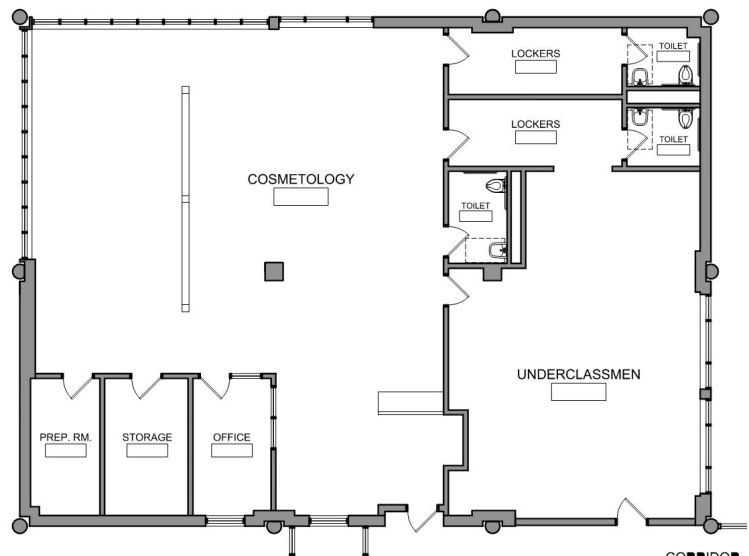
Contains office, storage room and prep room

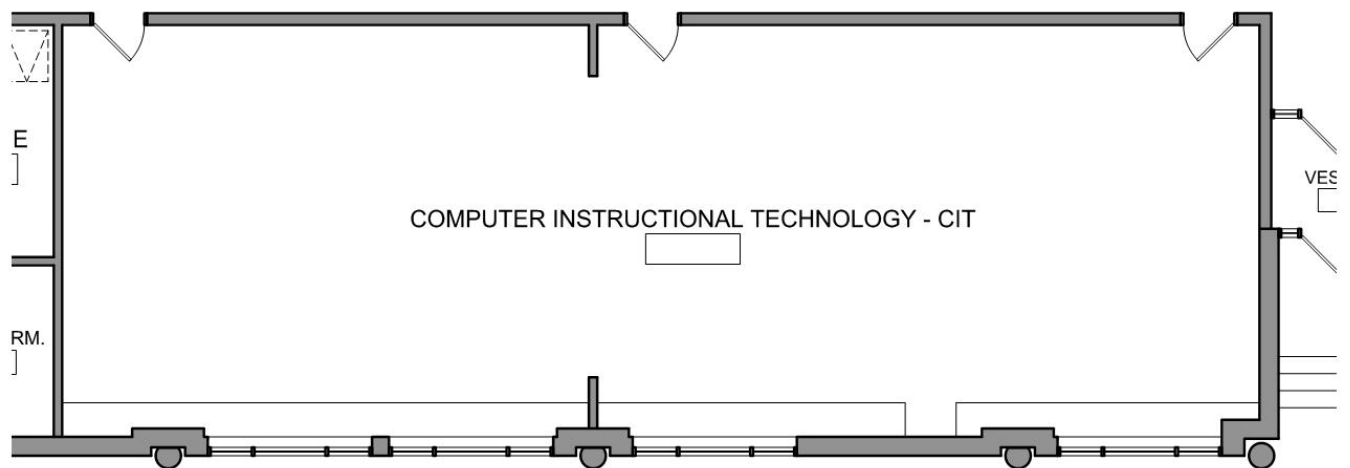
This space was originally two smaller classrooms
